Manhole Inspection Summary

Manhole # S21A__004MH

Insp Date: **10/22/07 9:42 AM**

Location Address: **703 MONROE ST**

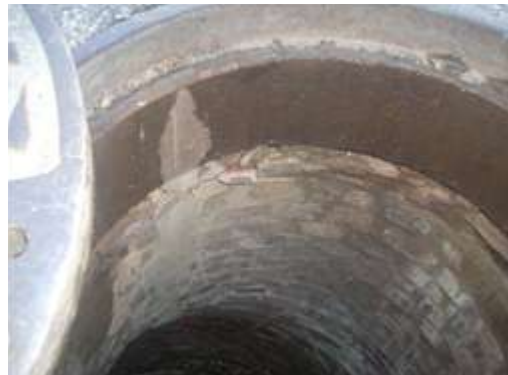
Defect 3

Condition: ☐ Sound ☐ Cracked ☐ Root Intrusion ☐ Loose Brick ☒ **Deteriorated**

CORBEL DETERIORATION

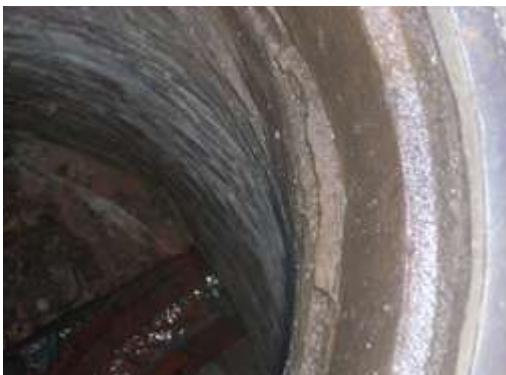
Defect 2

Steps Count: **0** Missing: **4** ☐ Corroded

NO STEPS, ALL MISSING

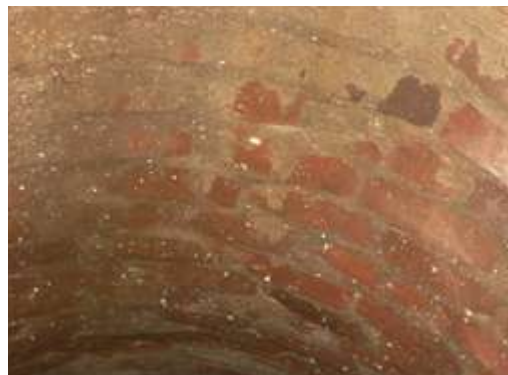
Defect 1

Surcharge ☒ **Evidence Of Surcharge** Depth: **4** (ft.) ☐ Active Surcharge Present

SURCHARGE EVIDENCE ON WALL

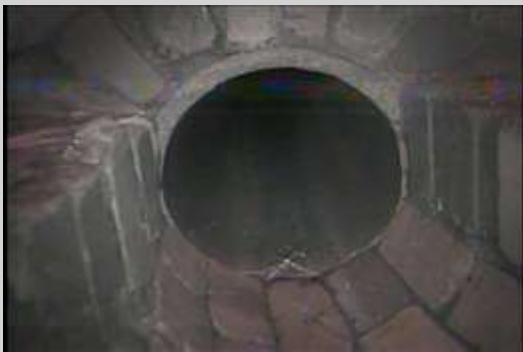
12 O'Clock Outflow

Pipe Height: **8.4** (in.) Rod and Bar (Angled)
Pipe Material: **Clay** ☐ Pipe Lined
Invert Depth: **8.15** (ft.) Flow Characteristics: **Slow**
Deposits: ☒ None ☐ Mud ☐ Sludge ☐ Debris ☐ Grease
Silt Depth: (in.) Deposits Extent:
Infiltration: **None** Pipe Seal Cond: **Sound**

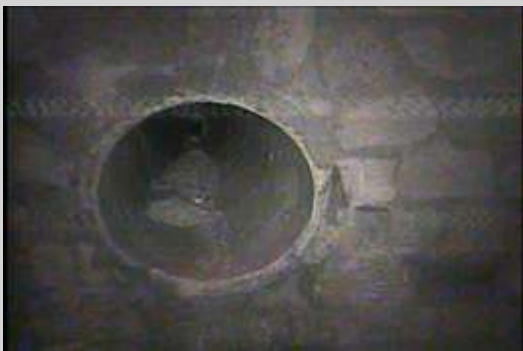
3 O'Clock Inflow

NO STEPS, ALL MISSING

Pipe Height: **7.2** (in.) Rod and Bar (Angled)
Pipe Material: **Clay** ☐ Pipe Lined
Invert Depth: **5.31** (ft.) Flow Characteristics: **Slow**
Deposits: ☒ None ☐ Mud ☐ Sludge ☐ Debris ☐ Grease
Silt Depth: (in.) Deposits Extent:
Infiltration: **None** Pipe Seal Cond: **Sound**

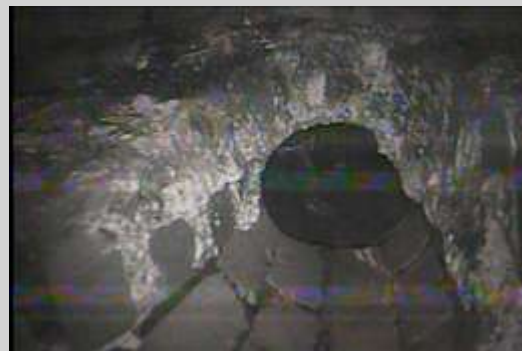
Drop In @ 3 O'Clock

NO STEPS, ALL MISSING

Drop: **Outside** Rod and Bar
Angled: **Yes** Reading: **7.04** (ft.)
Inv Depth: **8.04** (ft.)
Drop Condition: **Open**
